INDOOR AIR QUALITY ASSESSMENT

The Children's Castle at John C. Page Elementary School 694 Main Street West Newbury, Massachusetts

Prepared by:
Massachusetts Department of Public Health
Bureau of Environmental Health Assessment
Emergency Response/Indoor Air Quality Program
June 2003

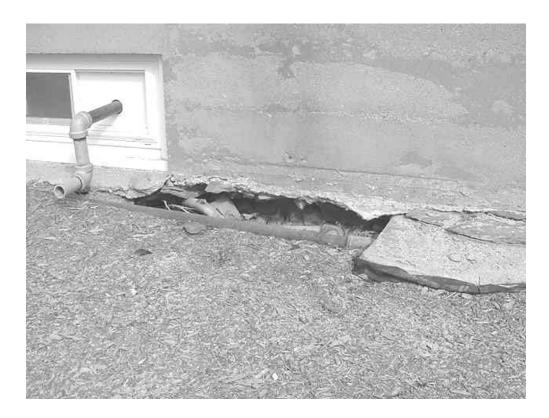
Picture 1

Large spaces/holes were noted along the exterior concrete foundation (see Picture 1).

Although no evidence of water penetration was noted opposite these spaces on interior basement

walls, these breaches in the building envelope can eventually lead to cracks and/or fissures in the foundation below ground level. Over time, this process can undermine the integrity of the building envelope and provide a means of water entry into the building by capillary action through foundation concrete and masonry (Lstiburek & Brennan, 2001).

Large Hole/Space in Concrete Foundation

Examine the areas around these areas for mold growth. Disinfect areas of water leaks with an appropriate antimicrobial as needed.
- 4. Seal/repair holes/spaces along foundation to prevent water penetration.
- 5. Report any signs of water penetration to the school maintenance department for prompt remediation.
- 6. Ensure plants have drip pans, examine drip pans for mold growth and disinfect areas with an appropriate antimicrobial where necessary.

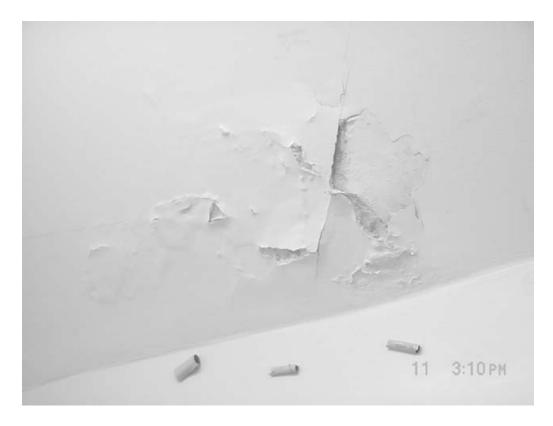
Picture 2

Several areas on the top floor had water damaged wall plaster and efflorescence (see Picture 2), which most likely resulted from historic roof leaks (no current leaks were reported). Efflorescence is a characteristic sign of water damage to brick and mortar, but it is not mold growth. As moisture penetrates and works its way through mortar around brick, water-soluble compounds in bricks and mortar dissolve, creating a solution. As the solution moves to the surface of the brick or mortar, the water evaporates, leaving behind white, powdery mineral deposits. As discussed, water penetration can lead to mold growth under certain conditions. Repairs of leaks are necessary to prevent further water penetration. The American Conference of Governmental Industrial Hygienists (ACGIH) recommends that porous building materials be dried with fans and heating within 24 hours of becoming wet (ACGIH, 1989). If not dried within this time frame, mold growth may occur. Once mold has colonized porous materials, they are difficult to clean and should be removed.

Efflorescence/Water Damaged Wall Plaster

- Use openable windows to control for comfort in classrooms without functioning
 ventilation systems. Care should be taken to ensure windows are properly closed at night
 and weekends to avoid the freezing of pipes and potential flooding.
- 2. For buildings in New England, periods of low relative humidity during the winter are often unavoidable. Therefore, scrupulous cleaning practices should be adopted to minimize common indoor air contaminants whose irritant effects can be enhanced when the relative humidity is low. To control for dusts, a HEPA filter equipped vacuum cleaner in conjunction with wet wiping of all surfaces is recommended. Drinking water during the day can help ease some symptoms associated with a dry environment (throat and sinus irritations).
- 3. Repair any existing water leaks and replace/repair any water-damaged building materials.
